Composite Failure Analysis Handbook Update #1

Boeing Defense & Space Group

April 1995

Final Report for the Period Aug 90 - Apr 95

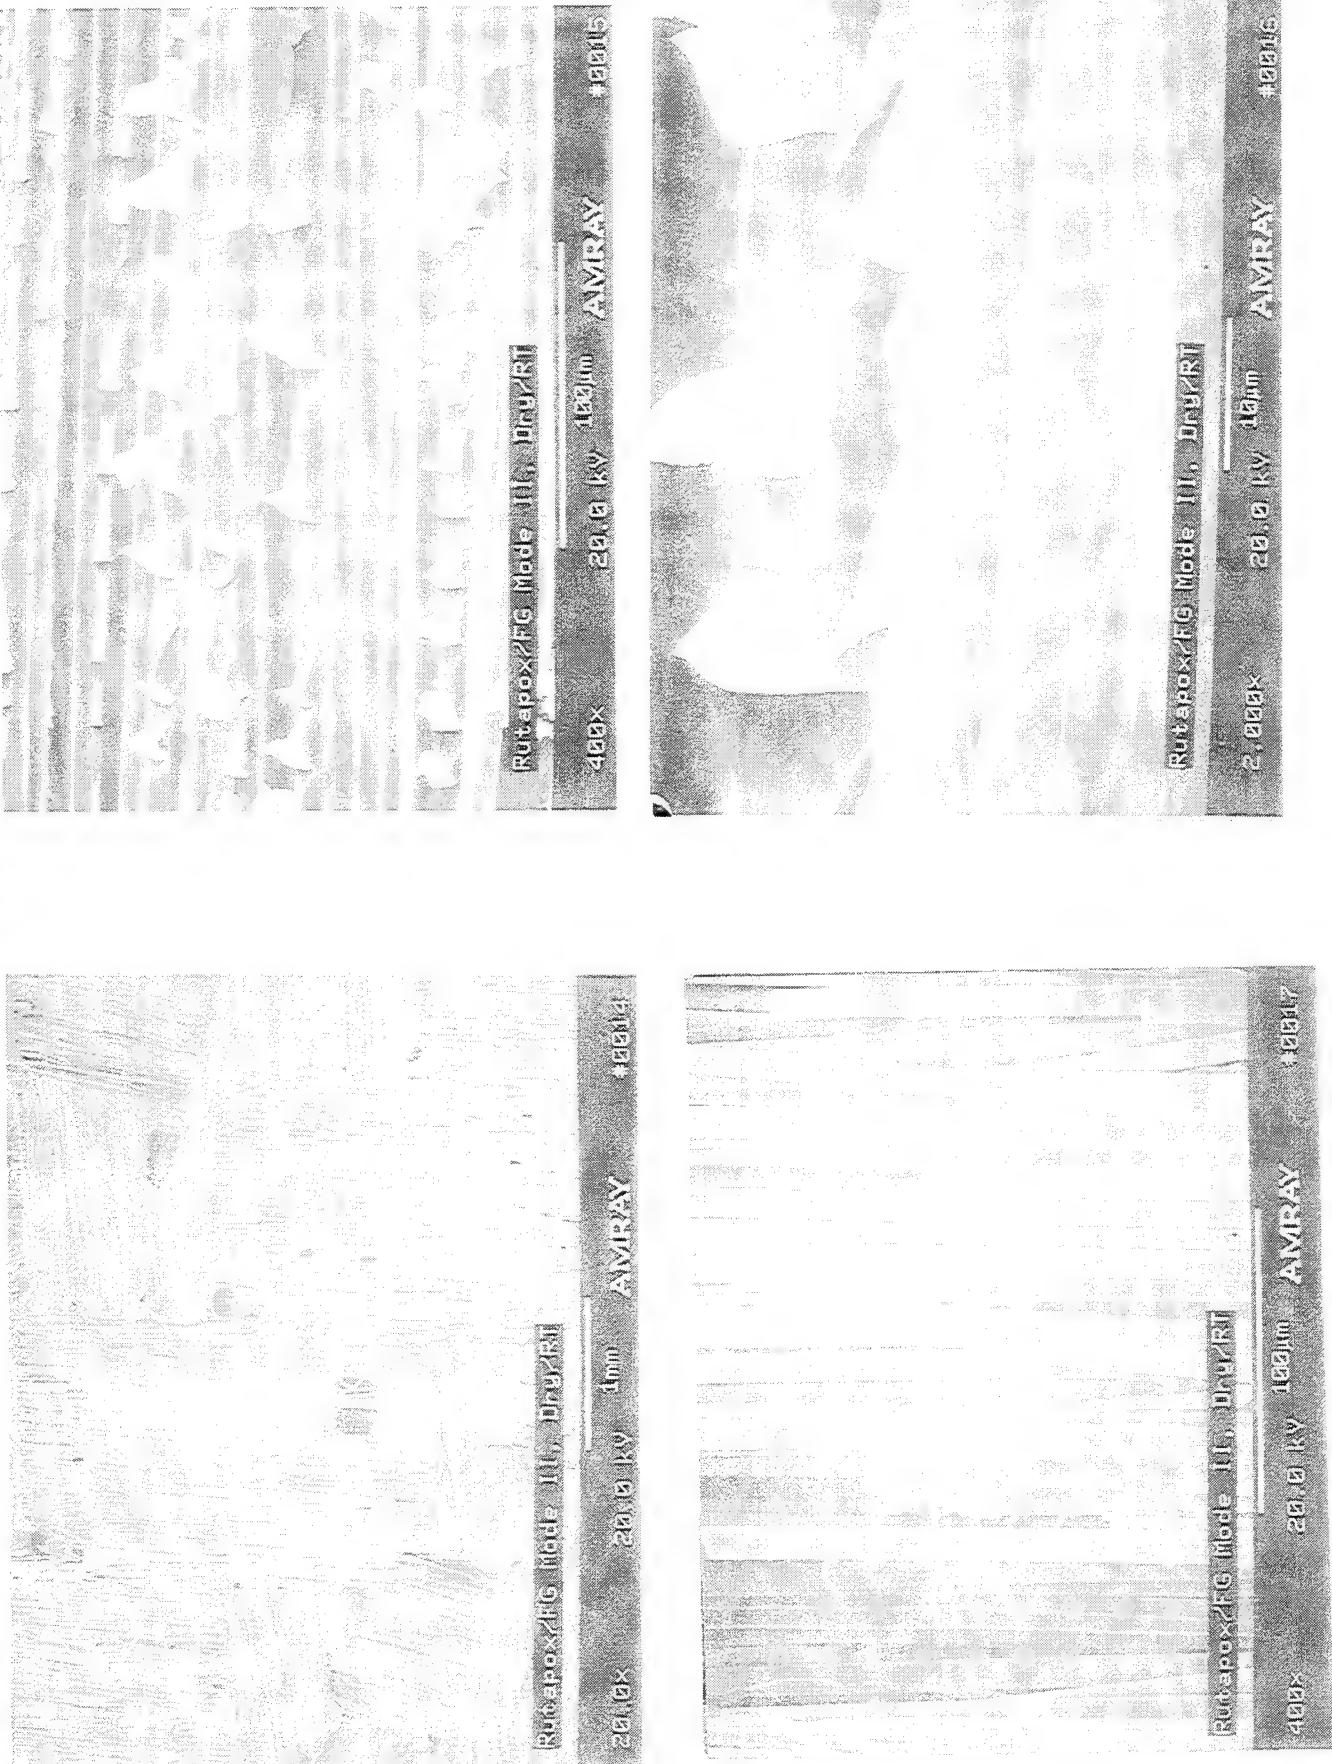
Figure 3.6-5. SEM Fractographs of a Rutapox/FG Fabric Interlaminar Mode II (Shear) Fracture Surface, RT

The fracture surfaces of both specimens exhibited similar features (Figure 3.6-4 & 3.6-5). The fabric tows parallel to the crack propagation orientation contained the hackles typical of a shear loading. Whereas the tows perpendicular to the crack direction exhibited ribbons of resin tearing from the fibers. The torn ends were generally bent towards the crack propagation direction.

The fracture surface of the RT/Dry specimen was composed mainly of resin which indicates that the crack propagated through the interface between the fabric surface (as seen in the Hot/Wet fractographs) and the resin. In addition, voids were also present at the fabric tow intersections

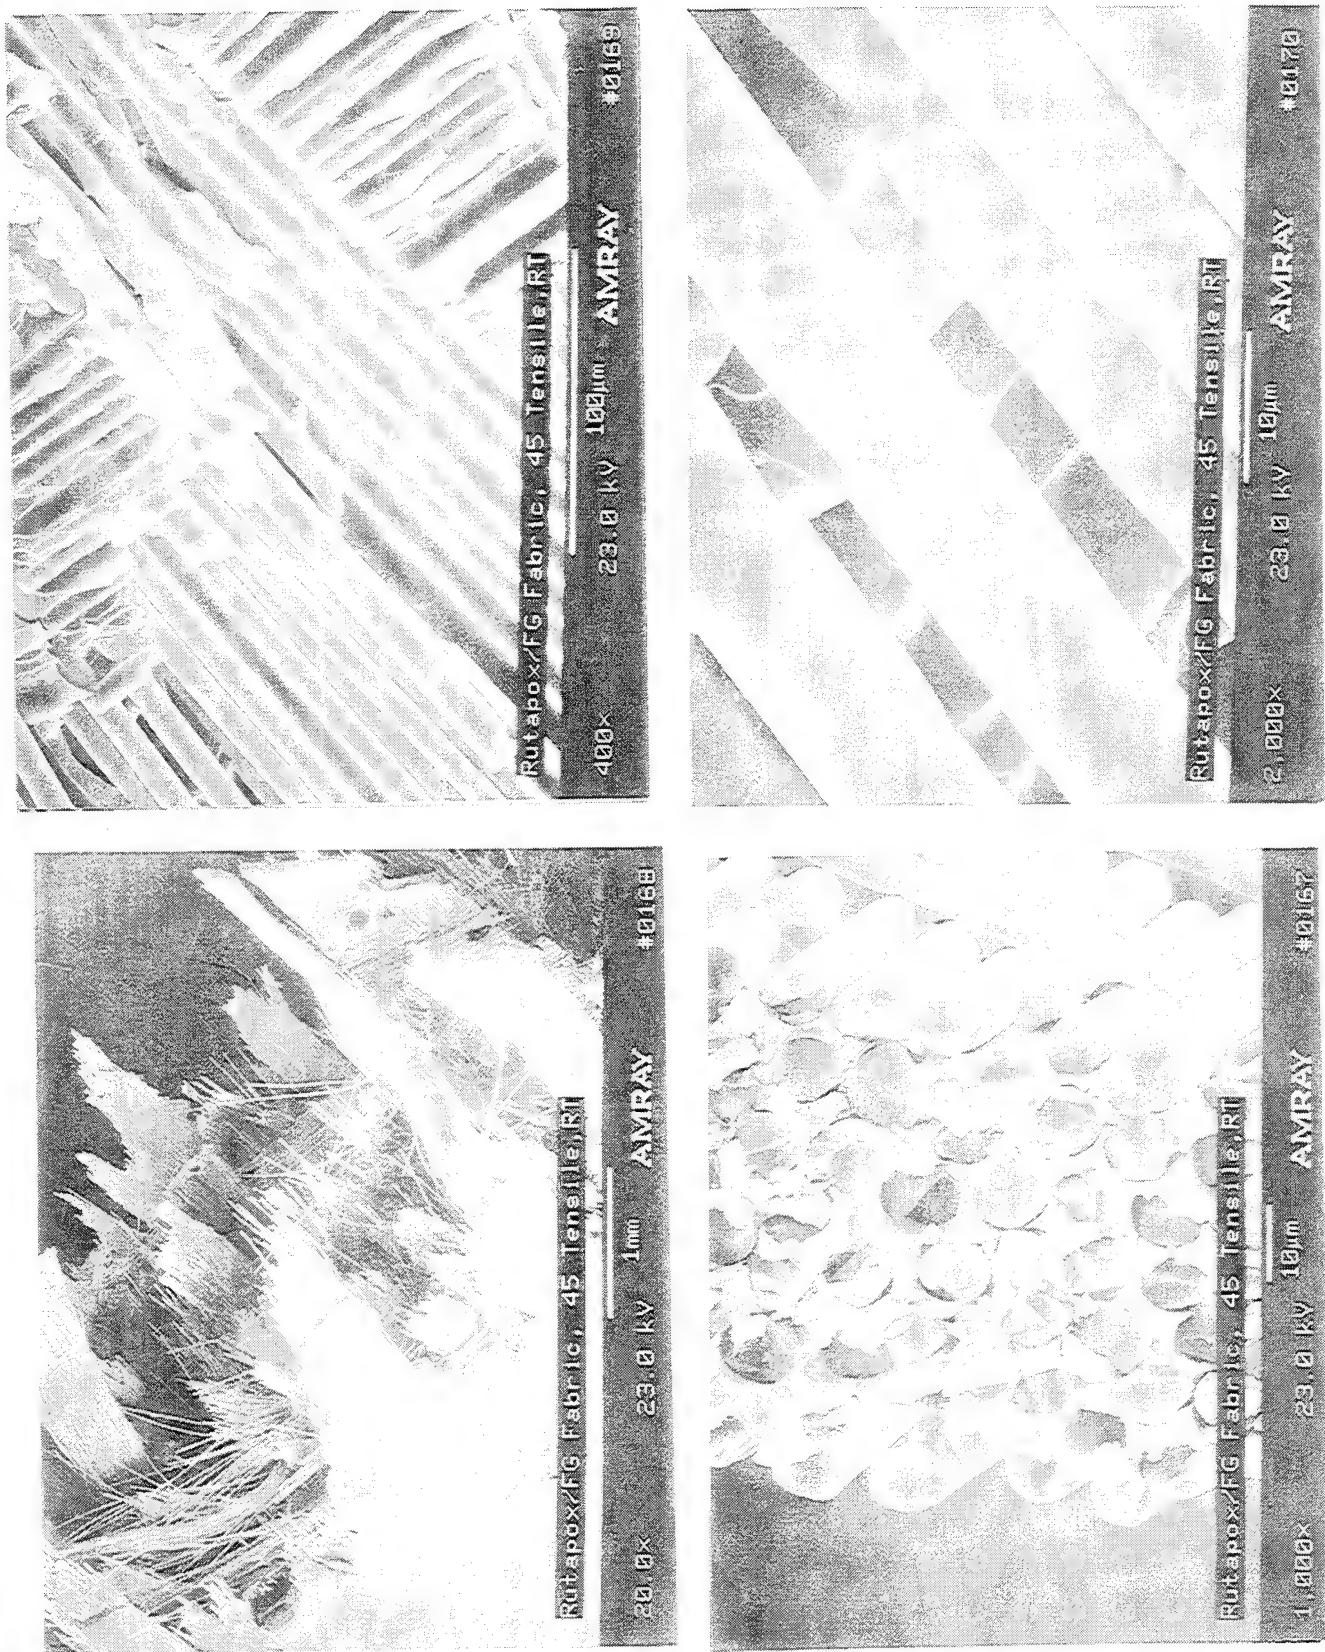
Figure 3.6-7. SEM Fractographs of a Rutapox/FG Fabric at 45° Tensile Fracture Surface, RT

The fabric specimen fracture surfaces (Figure 3.6-7) were more consolidated as compared to the roving specimen surfaces. There were fewer fiber pullout regions but wetting of the fibers did not appear to be as thorough. Furthermore, unlike the roving specimen, the fabric fiber ends exhibited a fracture morphology indicative of a compression loading. These were also grouped in more bundles compared to the roving specimen fiber ends.

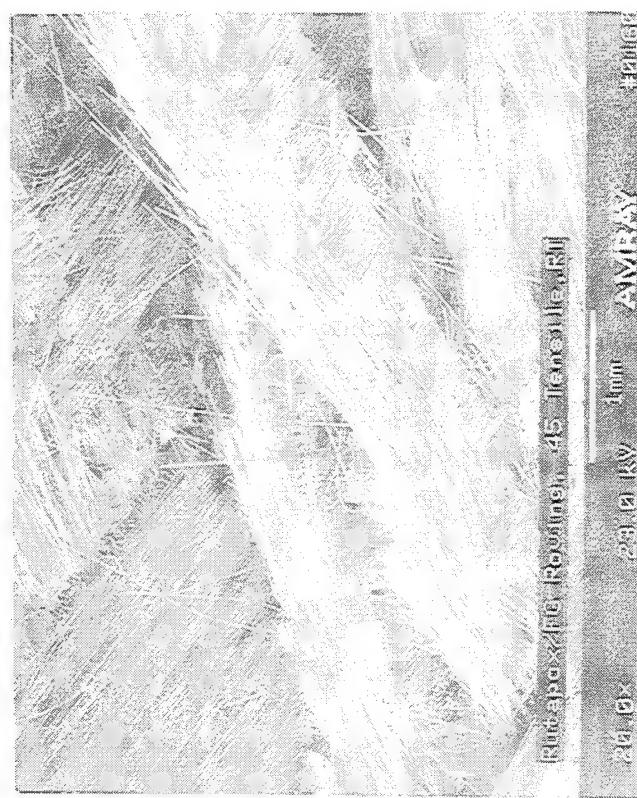
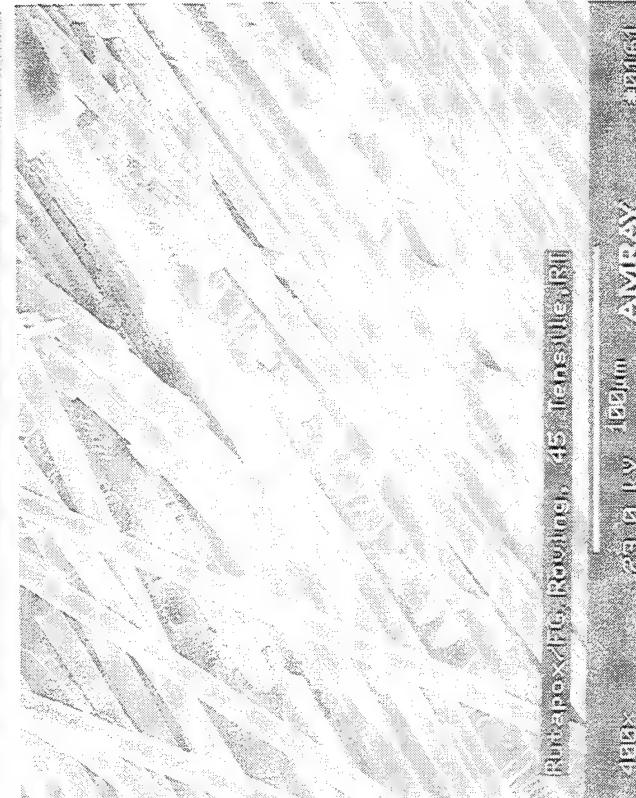
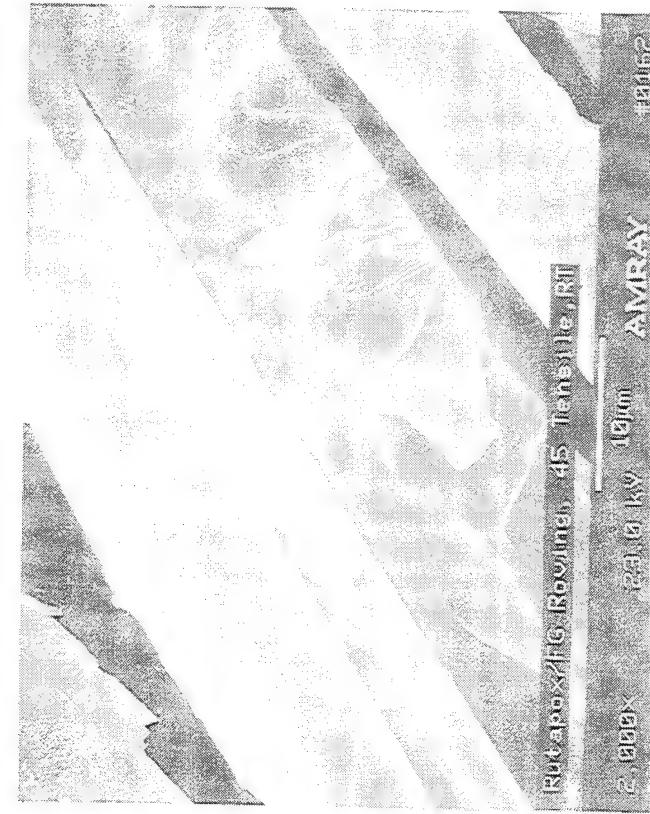
Figure 3.6-8. SEM Fractographs of a Rutapox/FG Rovings $\pm 45^\circ$ Tensile Fracture Surface, RT

In the specimen made using only rovings (Figure 3.6-8), the fracture surface exhibited primarily mode II fracture features with some limited regions of mode I. The overall appearance was very fibrous with a considerable amount of fiber pullout.

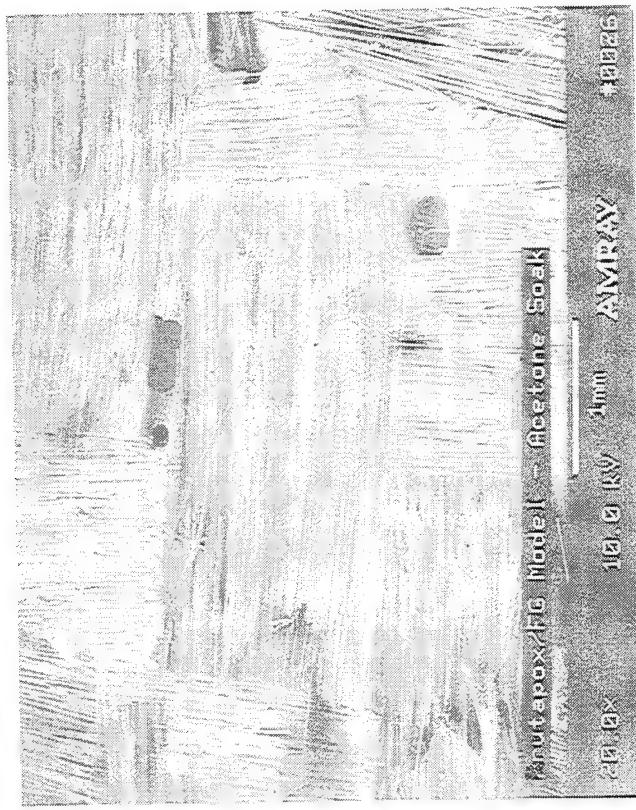
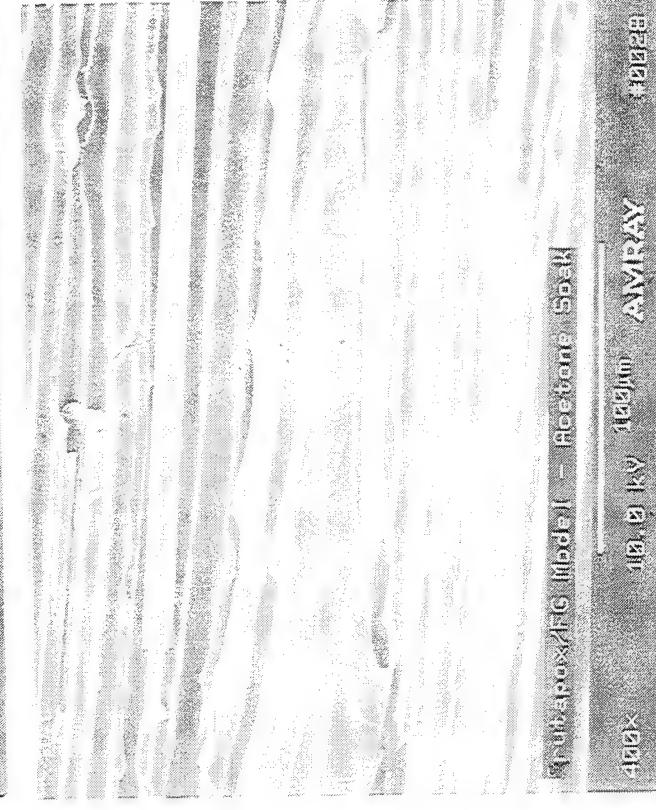
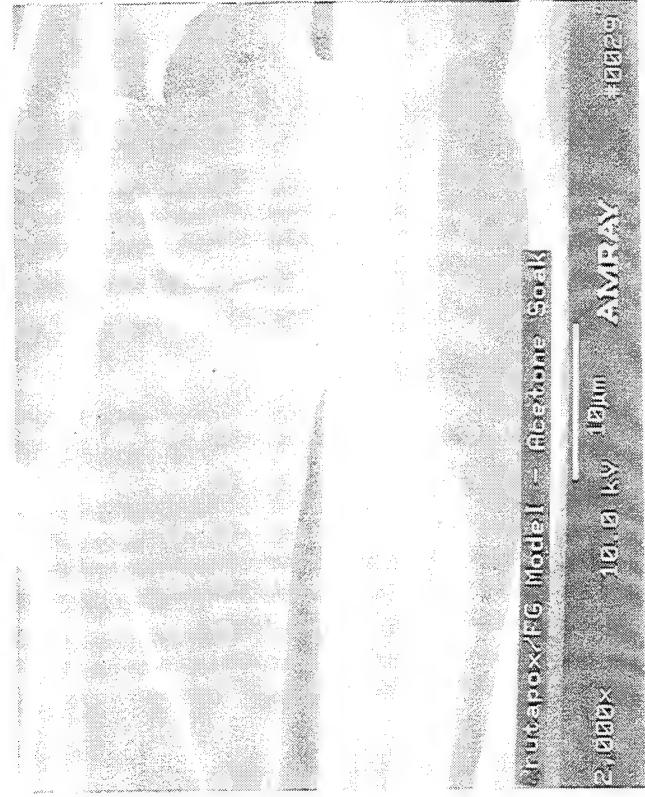
Figure 3.6-14. SEM Fractographs of a Rutapox/FG Fabric Interlaminar Mode I (Tensile) Fracture Surface Exposed to Acetone for 7 days

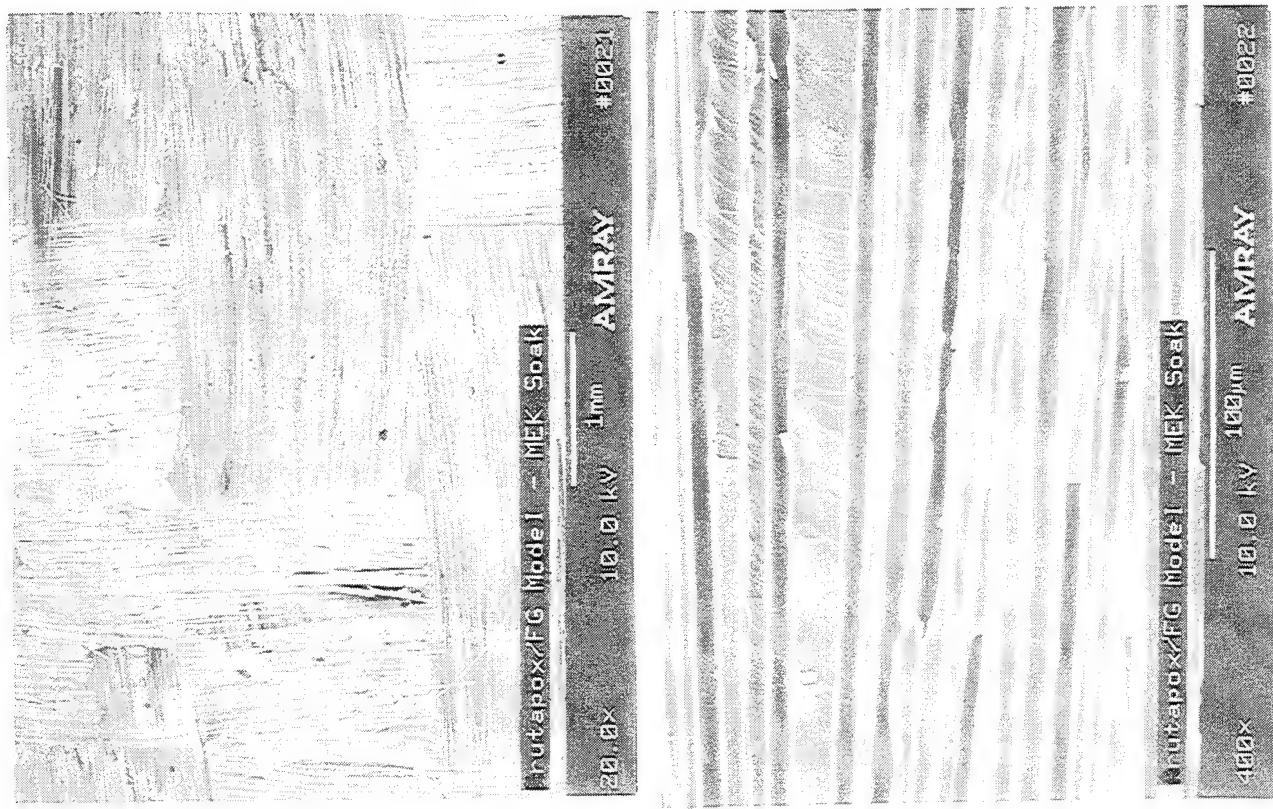
Figure 3.6-15. SEM Fractographs of a Rutapox/FG Fabric Interlaminar Mode I (Tensile) Fracture Surface Exposed to MEK for 7 days

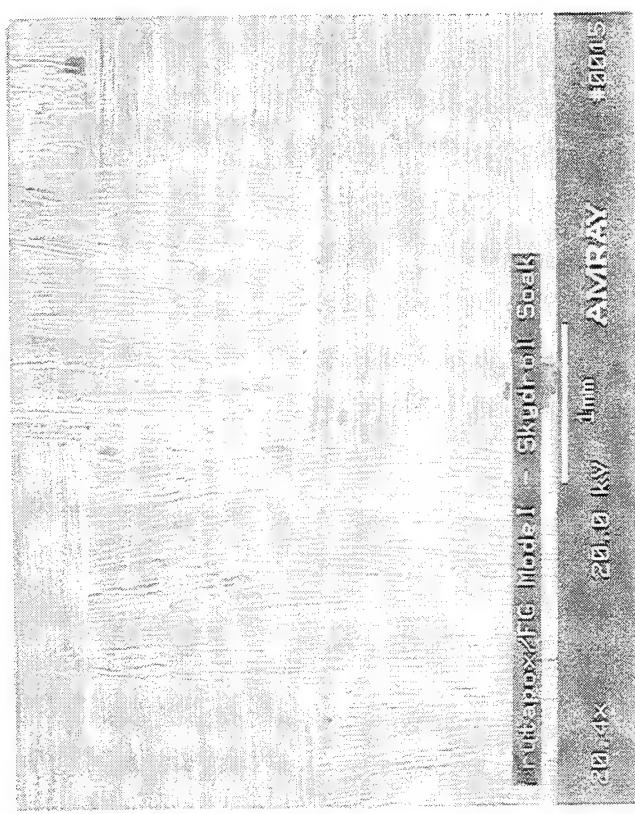
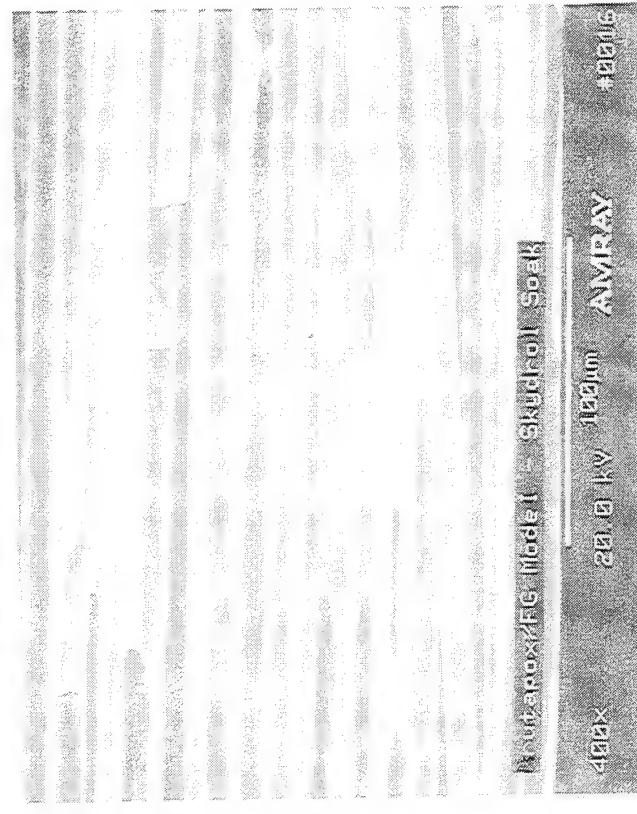
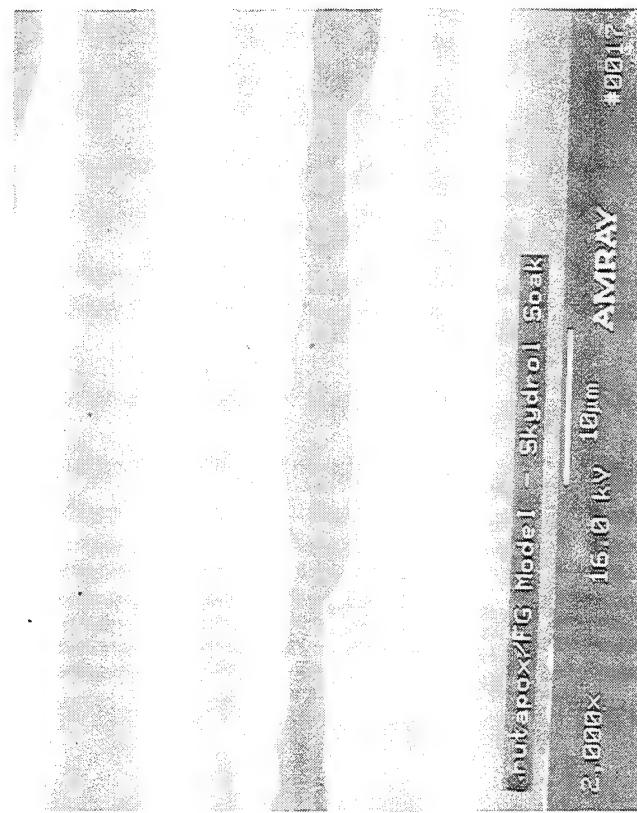
Figure 3.6-16.

SEM Fractographs of a Rutapox/FG Fabric Interlaminar Mode I (Tensile) Fracture Surface Exposed to Hydraulic Fluid for 7 days

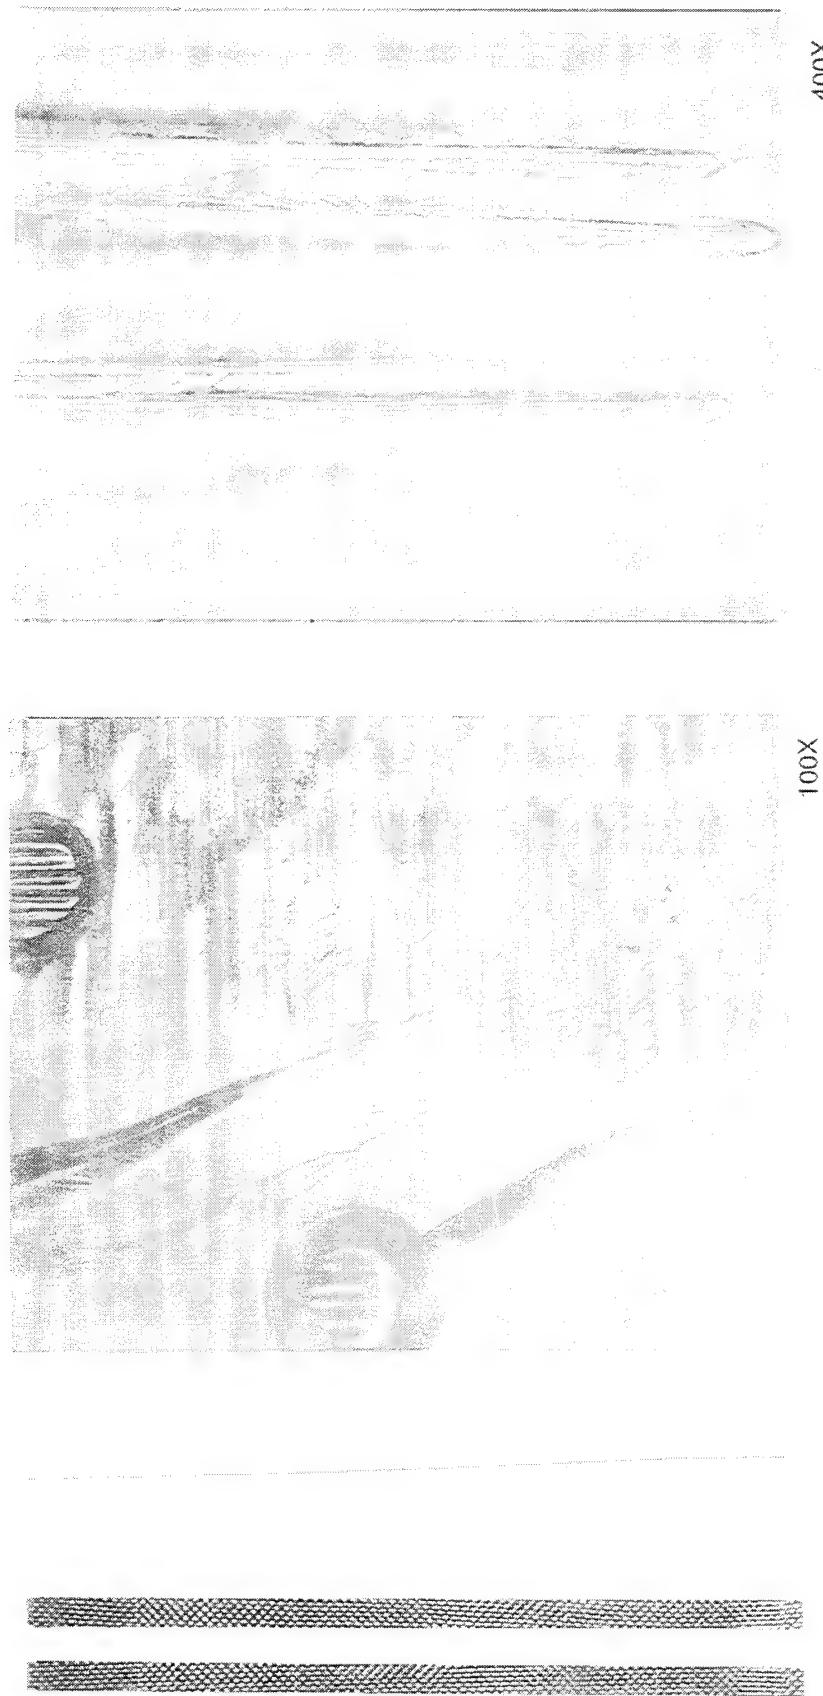
The fracture surface (Figure 3.7-1 & 3.7-2) contained numerous resin-rich regions with voids distributed throughout the surface. These voids were likely the result of panel processing rather than a specific material attribute. This resulted in an overall shiny appearance when examined visually. SEM examination (Figure 3.7-1) revealed numerous rivermarks in the resin-rich regions indicating the crack growth direction. The resin between the fibers perpendicular to the fracture direction was composed of hackles with no specific discernible fracture direction.

Figure 3.7-1. Optical Fractographs of a Rutapox/Graphite fabric Intertaninar Mode I (Tensile) Fracture Surface, RT

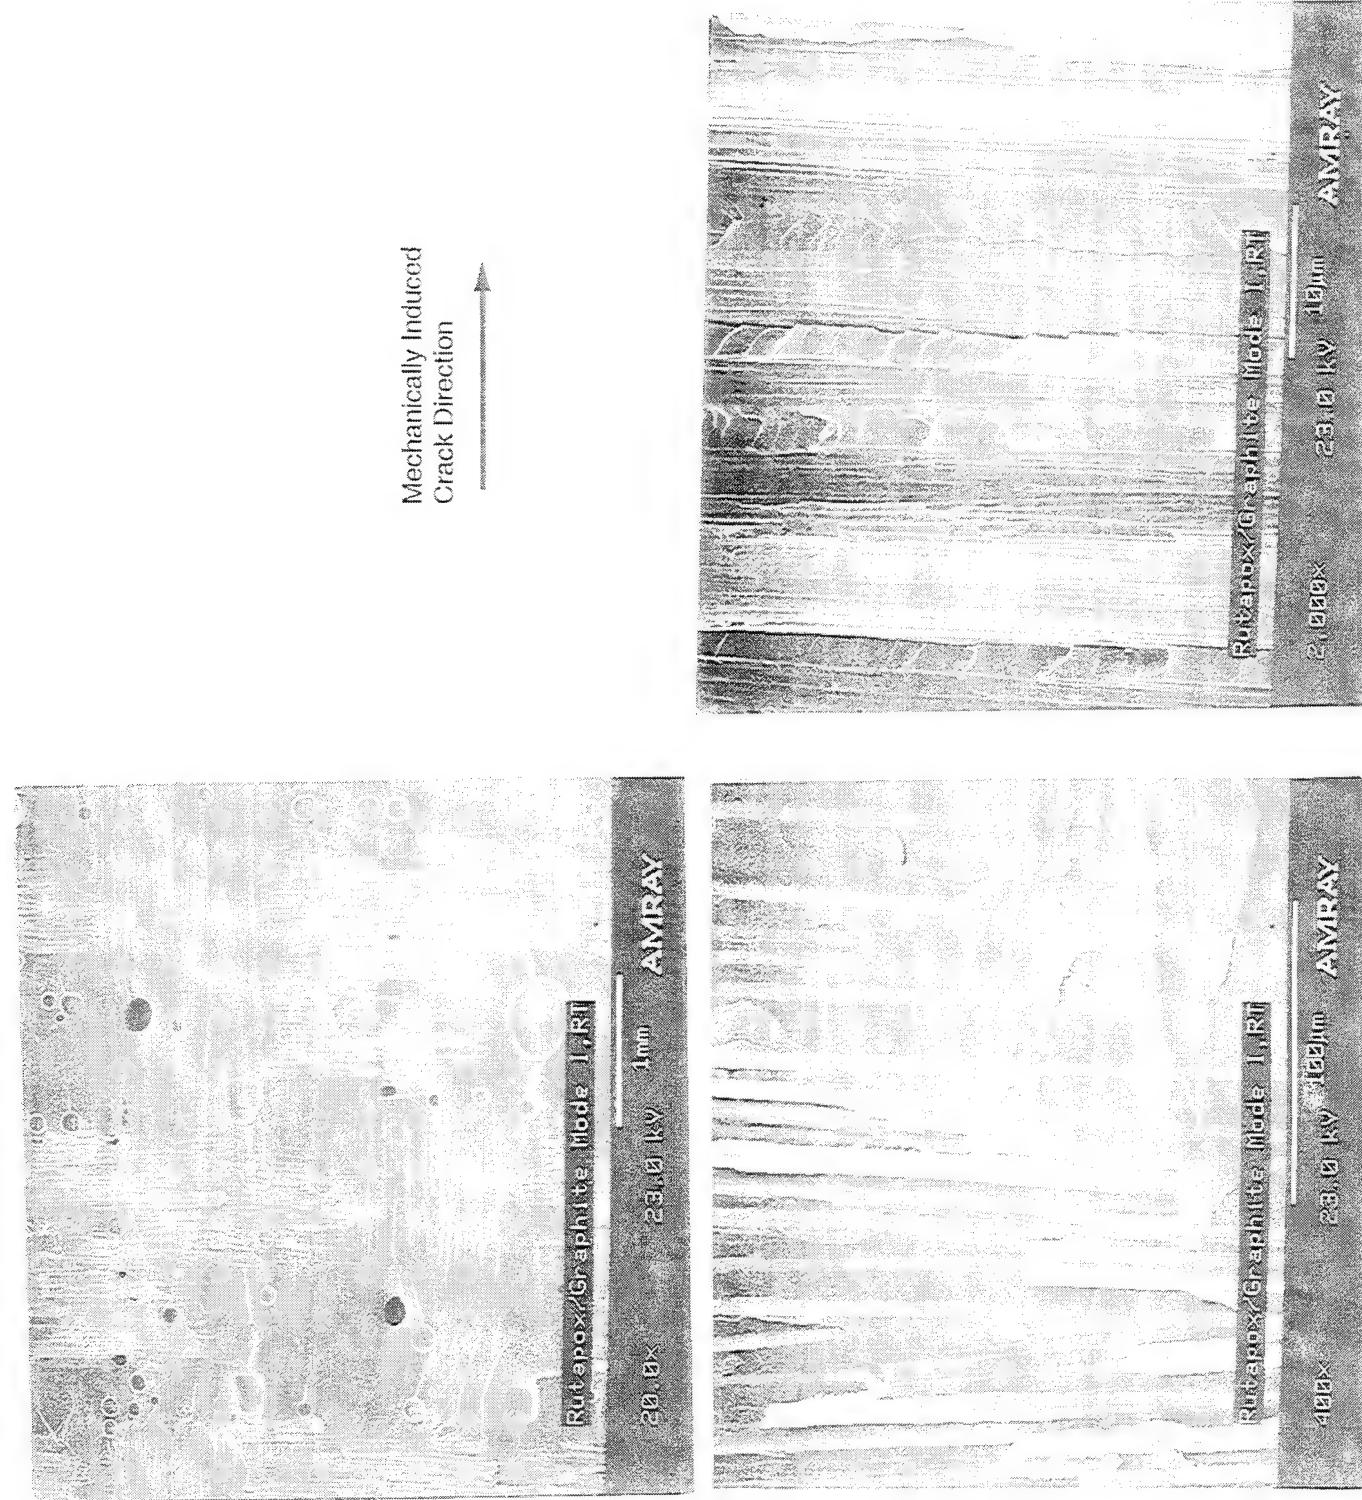
Figure 3.7-2. SEM Fractographs of a Rutapox/Graphite Fabric Intertaninar Mode I (Tensile) Fracture Surface, RT

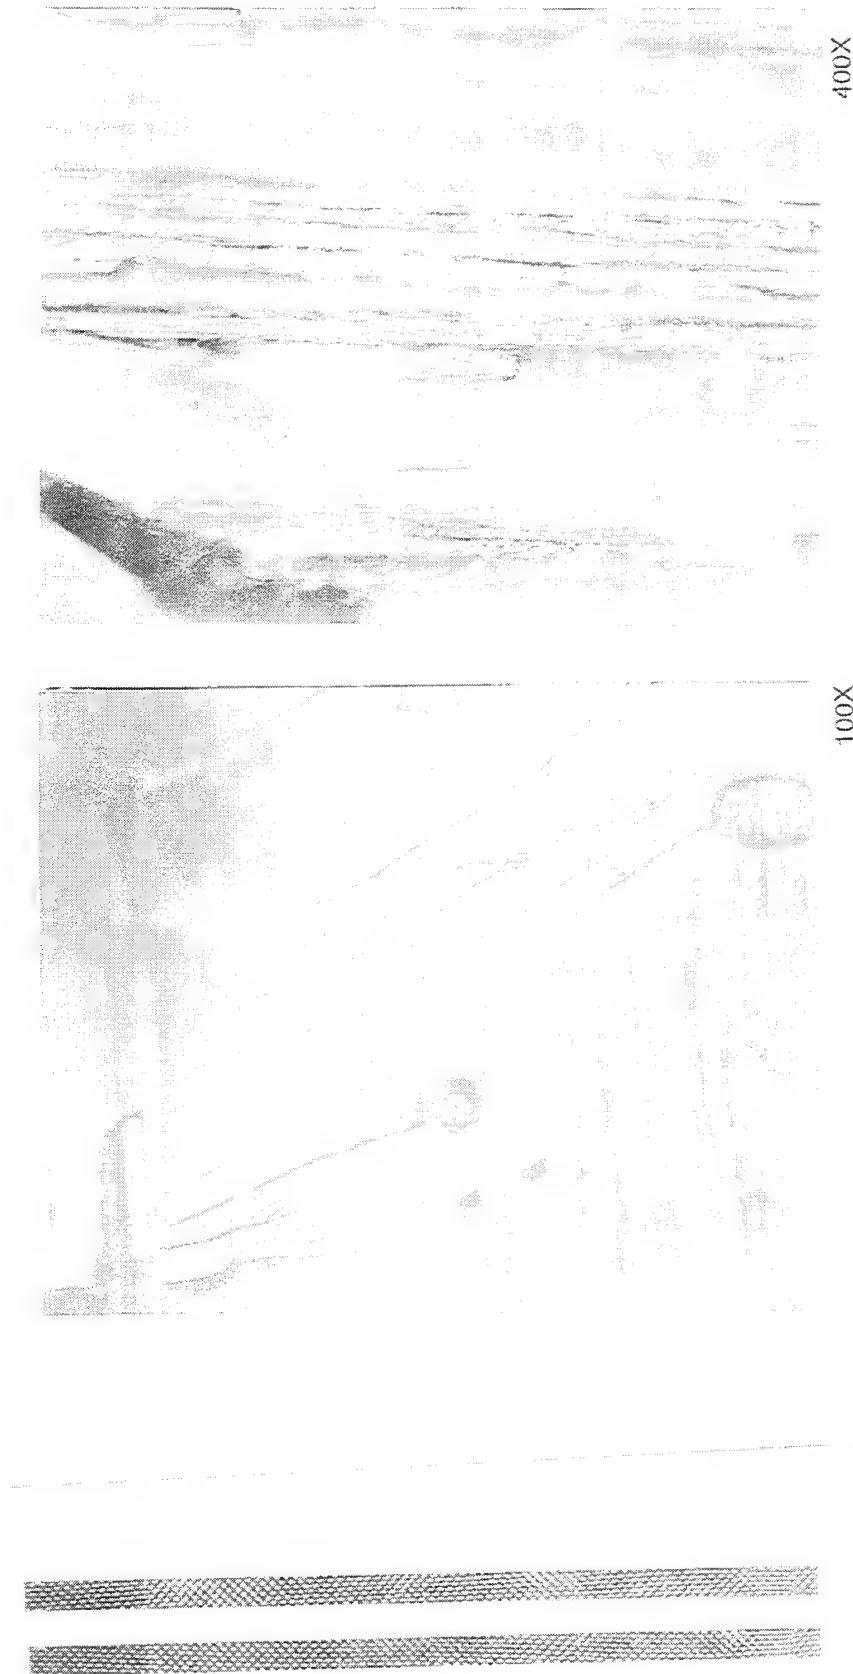
The high strain rate specimen fracture surfaces (Figure 3.7-3 & 3.7-4) were similar to the normal rate specimens, but the river patterns were more evident.

Figure 3.7-3. Optical Fractographs of a Rutapox/Graphite Fabric Interlaminar Mode I (Tensile) High Rate Fracture Surface, RT

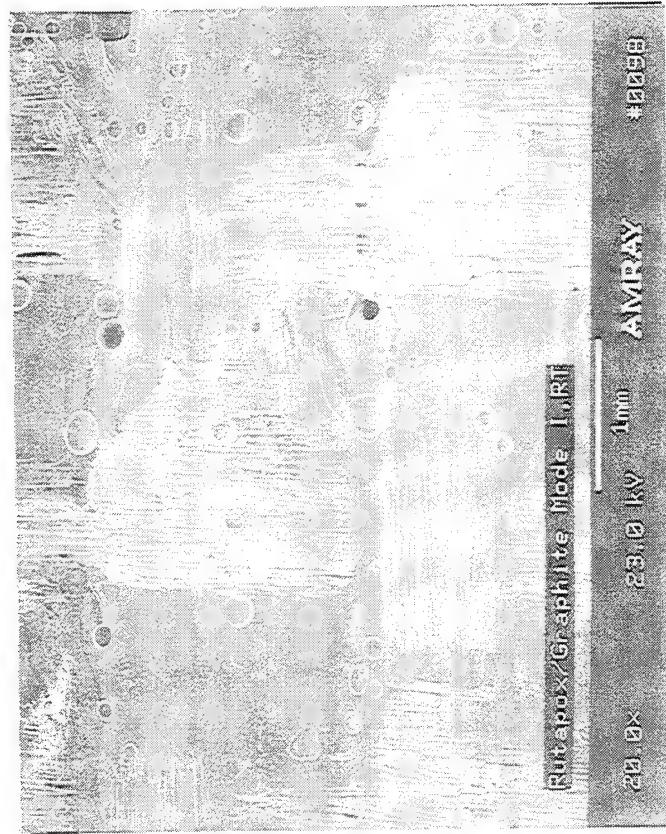
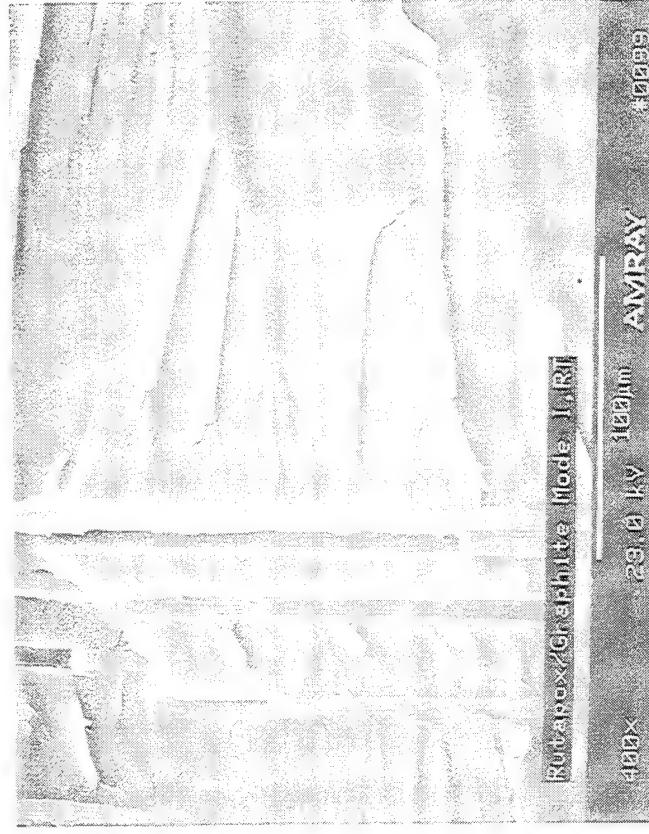
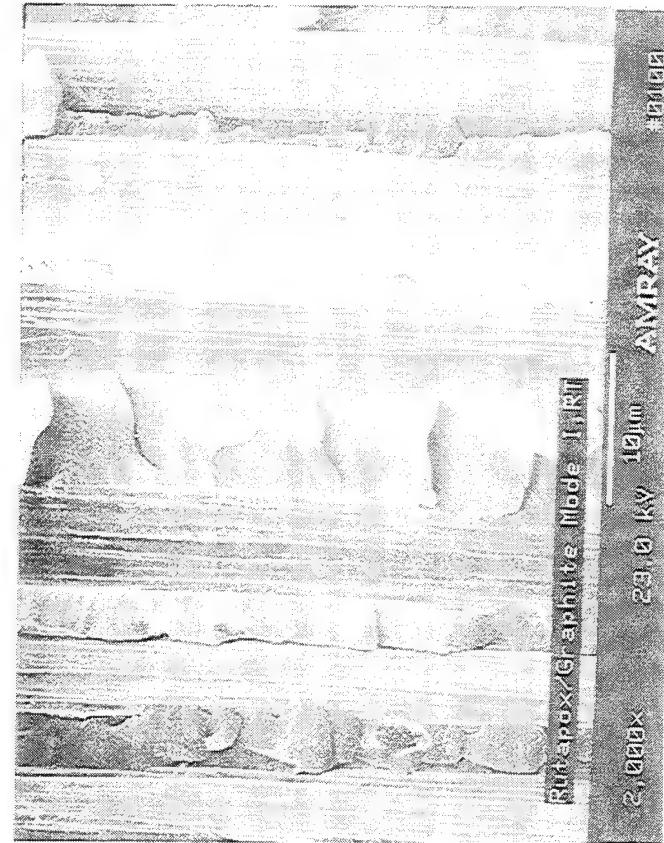
Figure 3.7-4. SEM Fractographs of a Rutapox/Graphite Fabric Intertwining Mode I (Tensile) High Rate Fracture Surface, RT

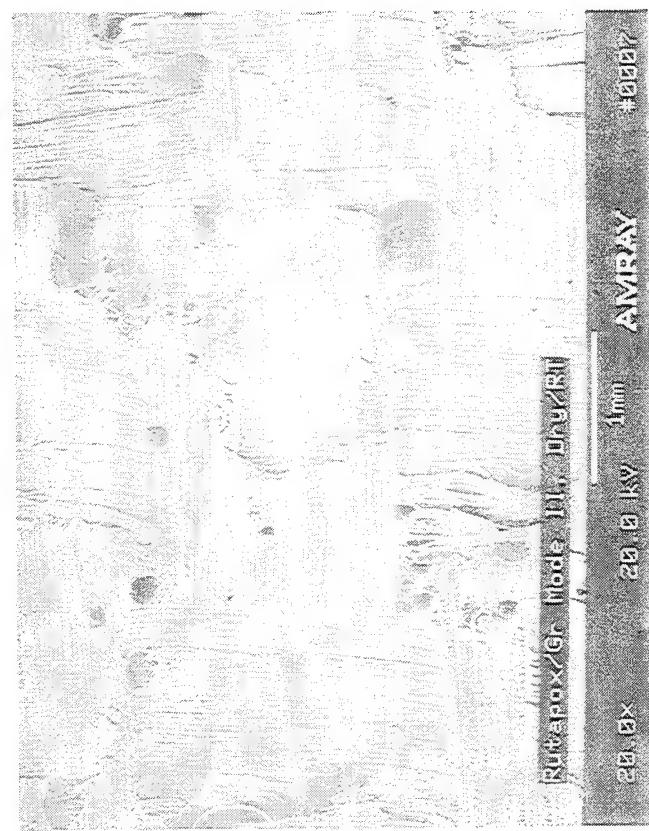
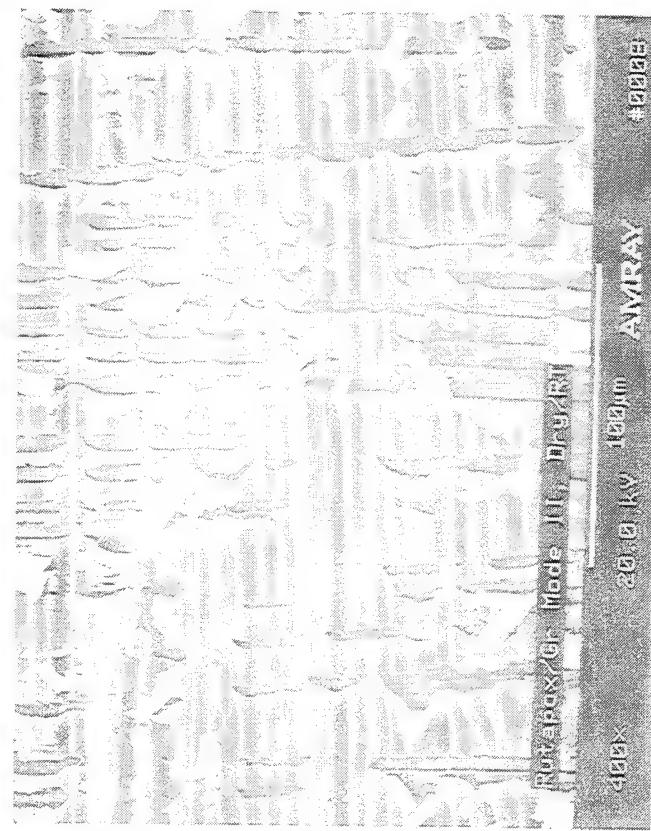
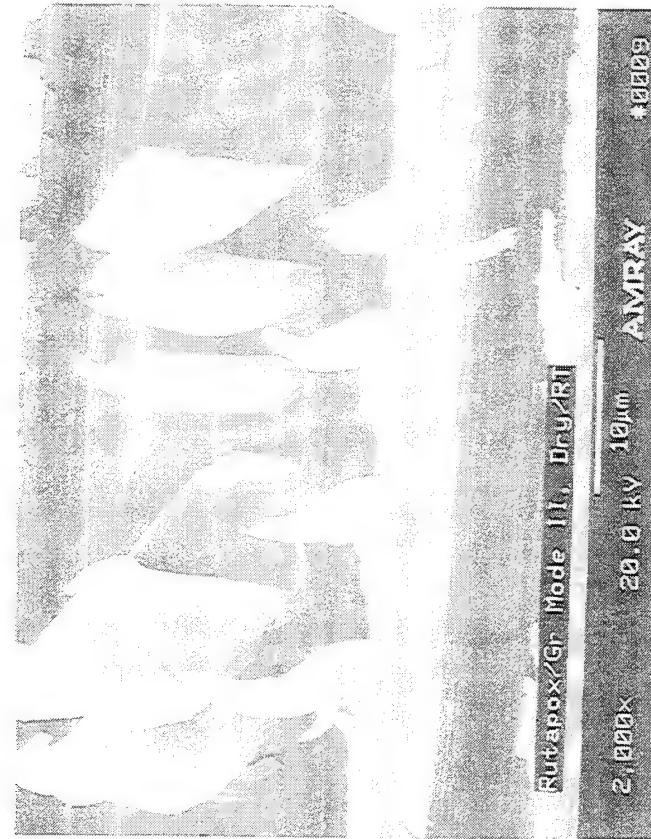
The visual appearance was generally rough similar to the mode I surfaces but with fewer shiny regions (Figure 3.7-5 & 3.7-6). The fracture surfaces were similar to the fiberglass specimens with the exception of the carbon fiber features as mentioned above. The fabric tows parallel to the crack propagation orientation contained the hackles typical of a shear loading and the tows perpendicular to the crack direction exhibited the ribbons of resin. The torn ends of the resin were generally bent towards the crack propagation direction.

Figure 3.7.5. SEM Fractographs of a Rutapox/Graphite Fabric Interlaminar Mode II (Shear) Fracture Surface, RT

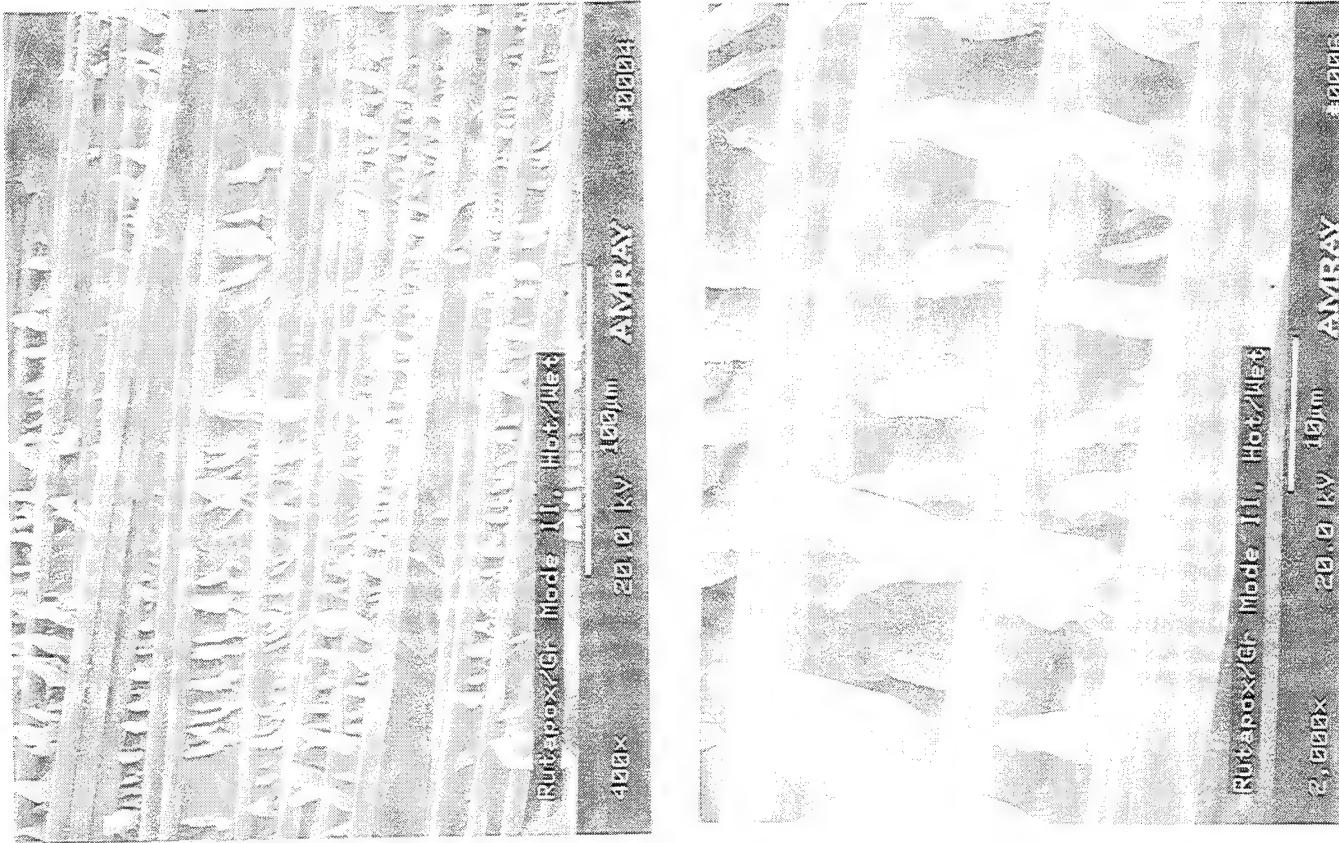
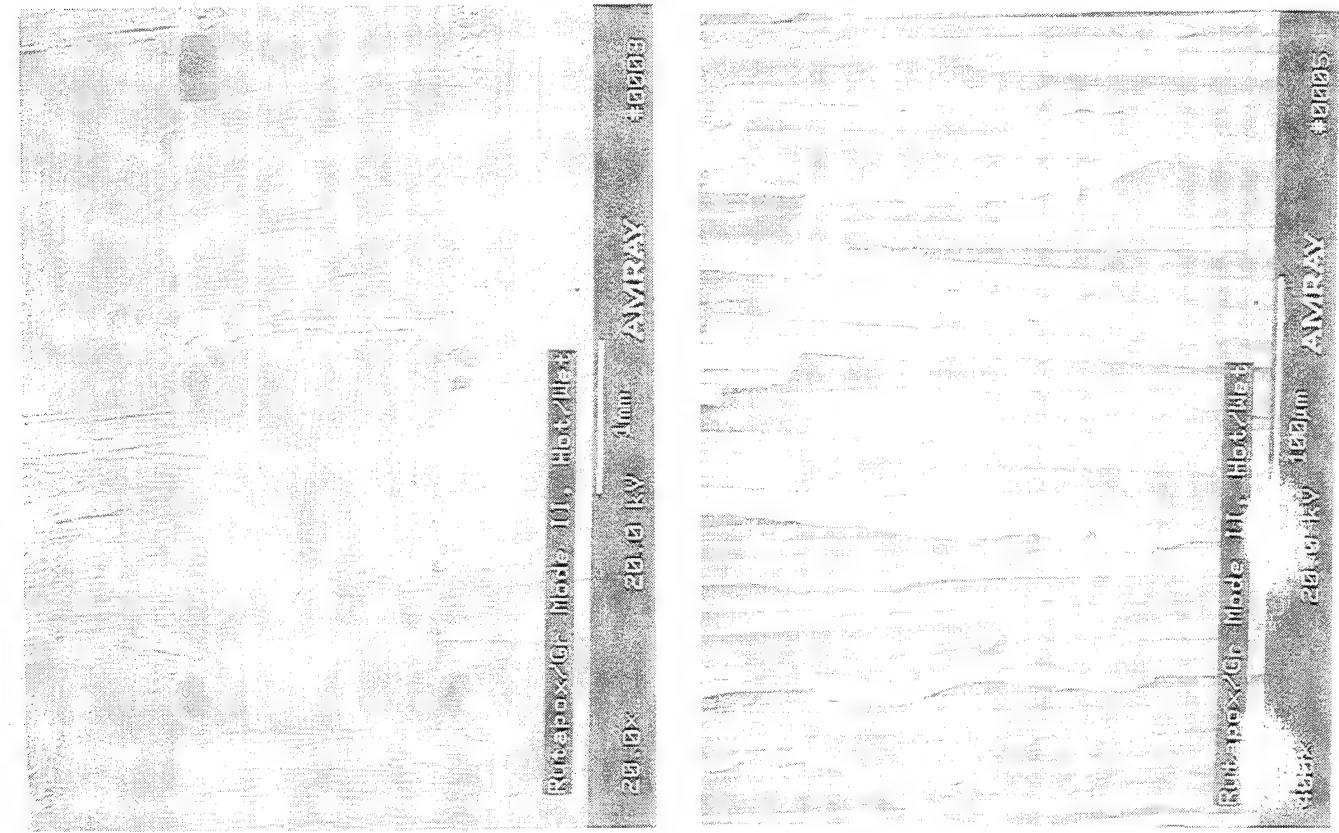
Figure 3.7-6. SEM Fractographs of a Rutapox/Graphite Fabric Interlaminar Mode II (Shear) Hot/Wet Fracture Surface, RT
